Our Reference: 24310:NB1983

RE: LEVEL 1 EARTHWORKS INSPECTION AND TESTING
OFFICER CENTRAL – STAGE 9 (OFFICER)

OFFICER CENTRAL
STAGE 9
ROAD AND DRAINAGE
ROAD LAYOUT PLANS - EARTHWORKS PLAN
CARDINIA SHIRE
YOURLAND PTY LTD

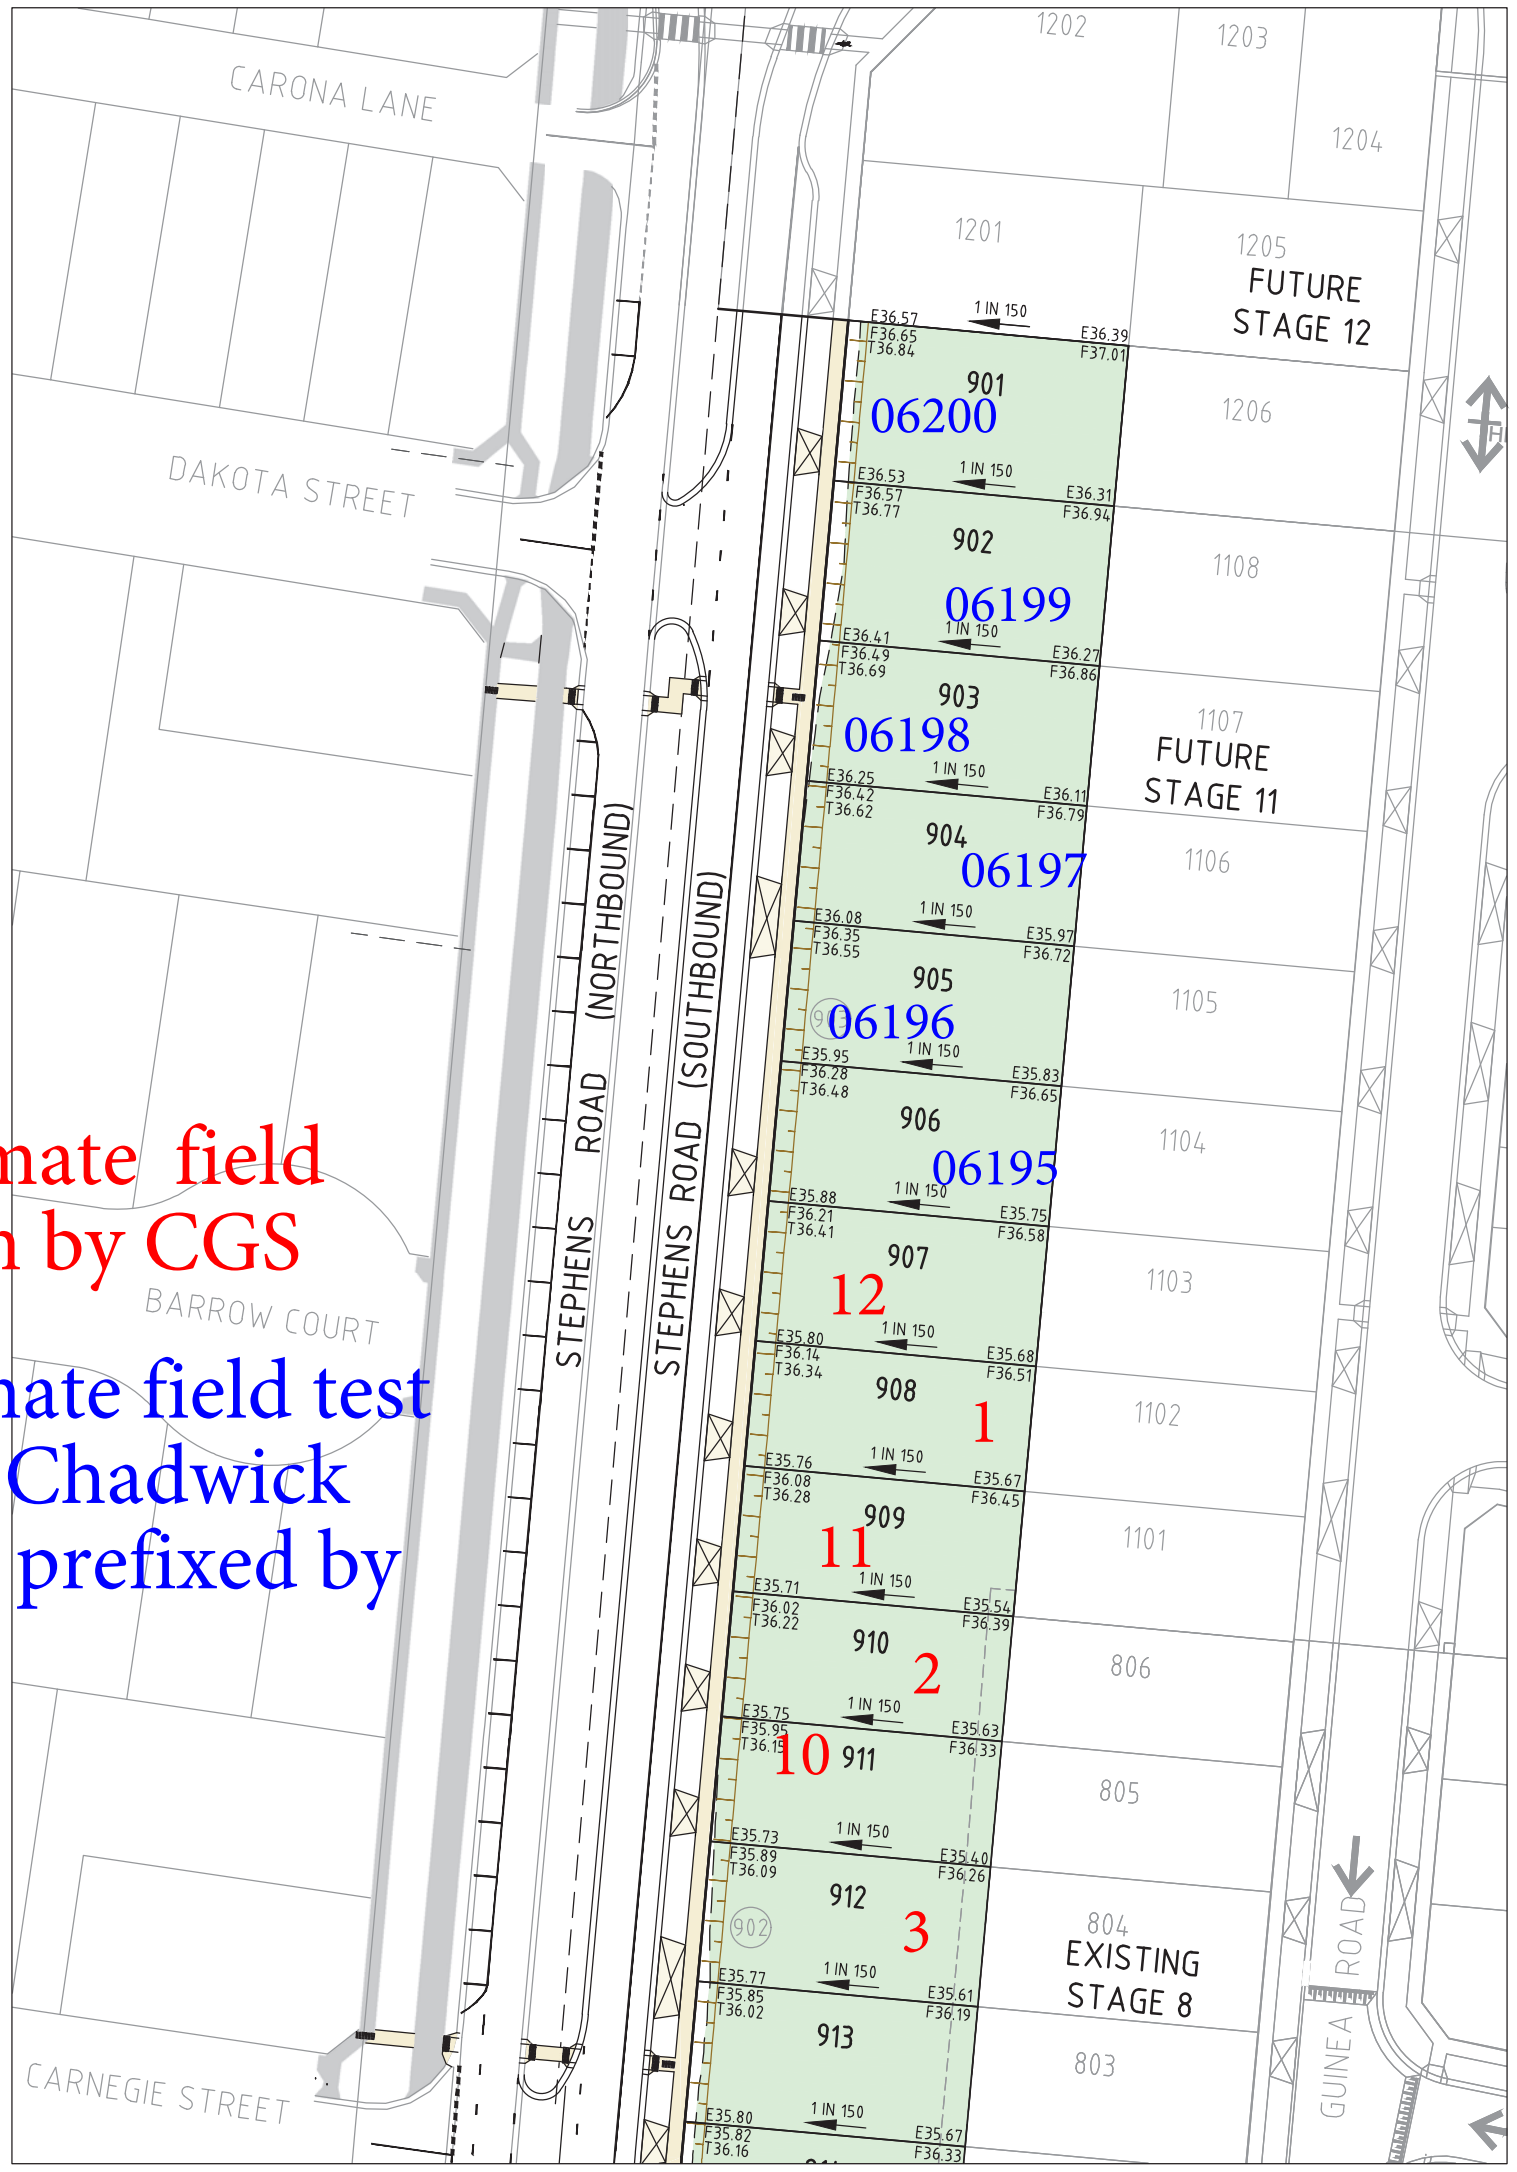
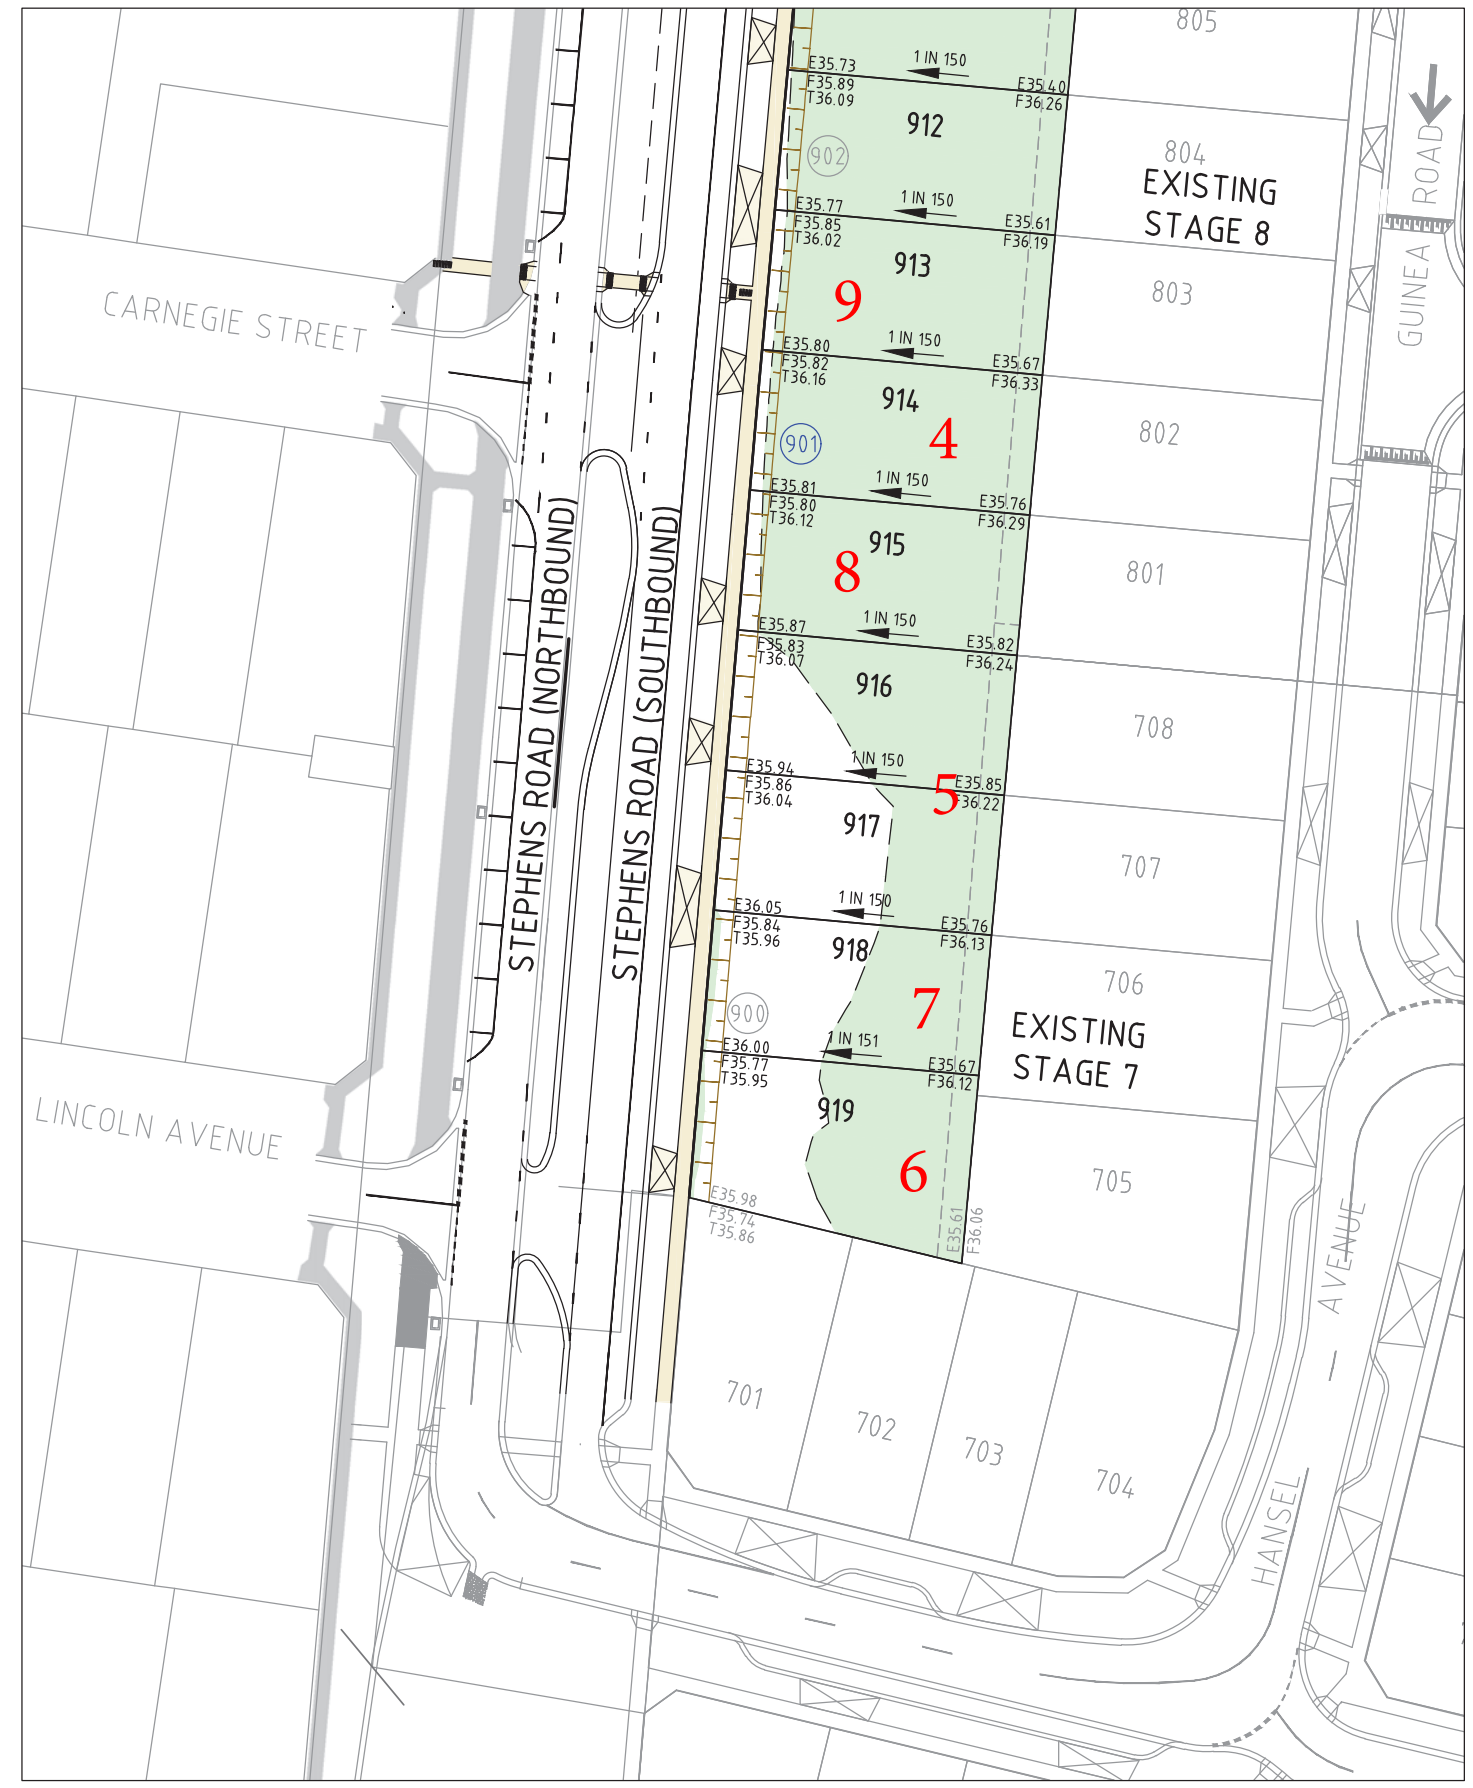
FIGURE 1

The site inspections and supervision were performed by experienced geotechnicians from this office. Any areas that were deemed unsatisfactory were reworked and retested under their supervision. The testing was performed to the relevant Australian Standards and the accompanying test reports carry NATA endorsement. The attached compaction results, which were located randomly throughout the fill profile, are considered to be representative of the bulk fill materials that were placed across the reported allotments by Winslow Constructors during the aforementioned period. The approximate locations of the field density tests can be seen on the attached plan (Figure 1).

We are of the view that the bulk fill materials that have been placed across the reported allotments by Winslow Constructors during the aforementioned period can be considered as having been placed in a controlled manner to a minimum density ratio of 95% (standard compactive effort).
